# A Classic Inside Job

## All new frames for CIRRUS—with minimal disruption

Text and photographs by Maynard Bray

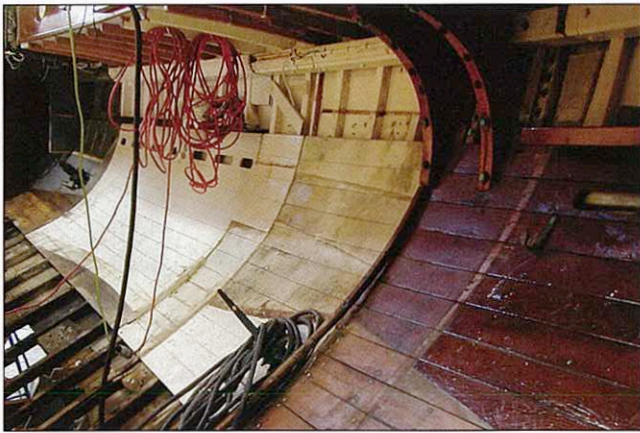
Because her bulkheads—and the rest of the interior joinerwork—landed on and attached to the boat's ceiling, they were easily removed for reuse, as Rick Clifton is doing here.

partitions, and cabinetry all landed on the ceiling, to which they were only lightly fastened. Herreshoff didn't use structural bulkheads like the boats of more recent vintage. The company built its hulls upside down, and one of the first operations after turning them upright was to install the ceiling—or inner planking. Only the ceiling had to be sacrificed to reframe CIRRUS, and it came out easily. Because it consisted of uniform-width strakes that ran the full length of the living spaces, milling out, fitting, and fastening a new bellyful of ceiling didn't take a great deal of time, either. After the new ceiling was in place, all of the original interior joinerwork was reinstalled.

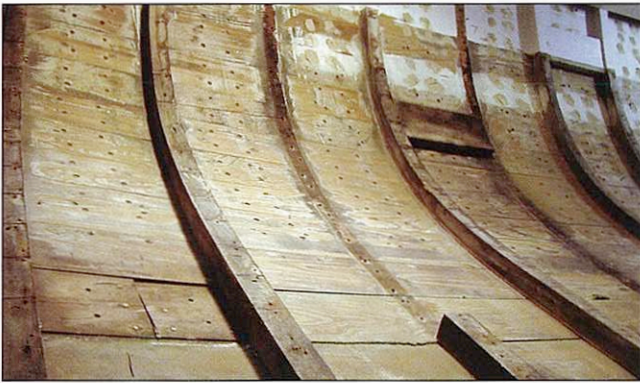
**Left, top**—You can see here how the various interior items have left their footprints on the ceiling. CIRRUS's fo'c's'le was varnished, while her main cabin was painted white. No attempt was made to reuse the ceiling.

**Left, lower**—Every other frame pair was split out to make way for new ones and to expose the threaded ends of the screw fastenings—which then could be driven out from the inside. Significantly, this enabled reuse of the same holes through the planking. With the access shown here, new back fastenings (the small flathead screws located in the frame bays that go through the inner layer of double-planking and into the outer layer) could be easily driven.

By gutting the boat and installing new frames from the inside, the existing screw holes in the planking could be reused; it would only be a matter of splitting out the old frames. This was done by sawing through the frames with a circular saw set shy of the frame's molded depth, followed by splitting the wood with a chisel to expose the screws, which could then be eased out to make way for laying in the new frame. All of this was done from inside the hull. Furthermore, the new steam-bent frames were brought inside through the gap left by the removal of the garboards and first and second broadstrakes; therefore the sheerstrakes, covering boards, deck, and sheer clamp remained undisturbed.

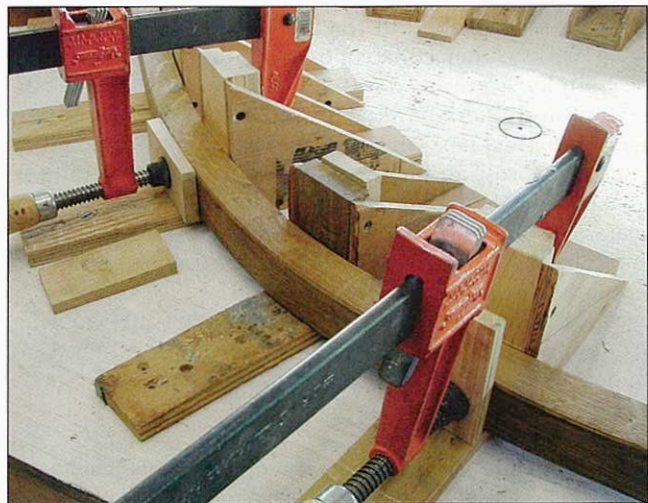
**Measurements for each new pair of frames were taken from the hull, but frames were prebent on the bending table shown here. They were given sufficient overbend to accommodate the springback that inevitably occurs as the clamps are removed.**

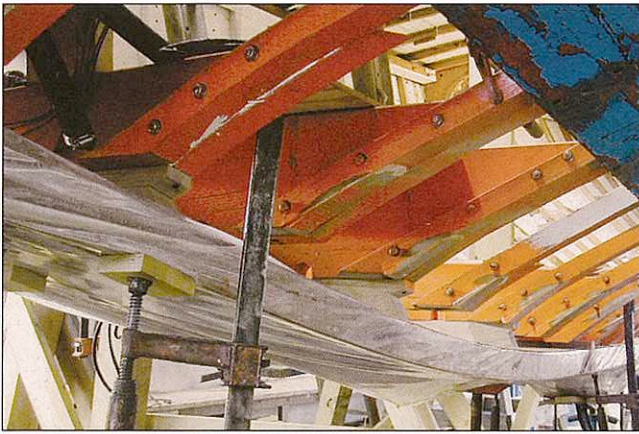
*Left, top*—The forward portion of CIRRUS's timber keel was judged okay, but not so with the aft portion, which required renewal. Like the original, this piece of oak had to be steamed and bent into a curve to fit against the floor timbers. In lieu of a steambox, the timber has been bagged with plastic (which shows here) and a steam hose inserted. As the wood became sufficiently limber, the piece was clamped into position. As with the frames, the keel timber has been somewhat overbent—accomplished in this instance by means of blocks sandwiched between keel and floors, and near the midpoint of the bend, as shown. *Left, lower*—New ceiling, in strakes matching the originals in cross section and glue-scarfed to match them in length, was sprung in and fastened after the framing was completed. The photo shows the terminus of the ceiling forward. Aft, Herreshoff had ceiled CIRRUS only as far as the cabin bulkhead, and that's where the new ceiling ended as well. The few frames aft of the ceiling's end were fitted with new lower portions. All the floor timbers from stem to stern, however, were renewed.

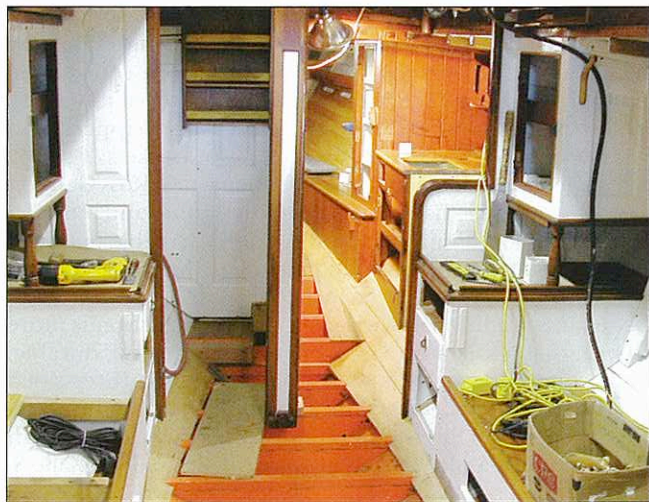
**After some refinishing, the original joinery was reinstalled against the new ceiling.**
